Capita Park.

Located at Capita Park in [Rotherham](#), this refurbishment project was delivered for [Set Square Surveyors](#) on behalf of Capita Customer Management. Works were carefully coordinated to avoid disrupting ongoing operations at this major UK call centre.

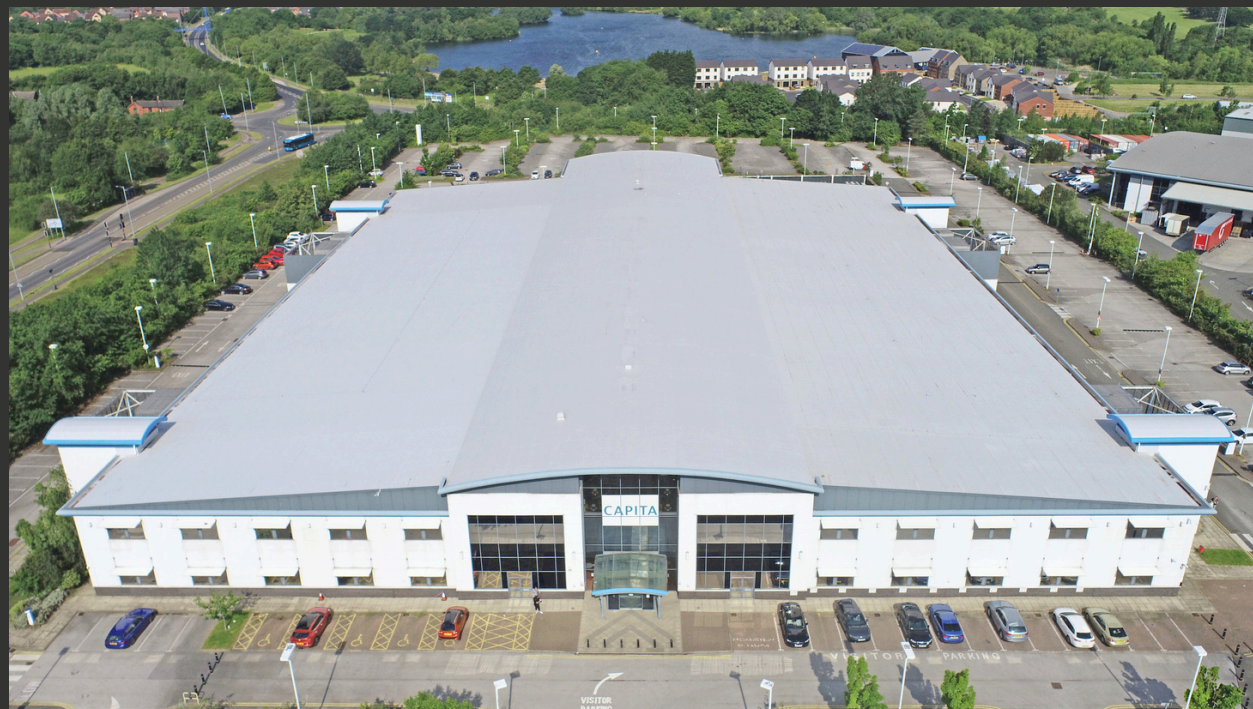
Single-Ply Installation
Liquid Waterproofing Detail
Thermal Insulation Upgrade
Fall Arrest System Installed

Sikaplan G-15 Single -Ply
Sikalastic Detailing
Tapered PIR Insulation
Roof Angel Safety Line System

With a budget of [£650,000](#), the [11,000m²](#) roof was refurbished to address water ingress, improve thermal efficiency, and extend the building's lifespan. The existing built-up single-ply system had reached the end of its serviceable life.

Central acted as Principal Contractor, managing a live, operational site with strict health and safety protocols. A single-ply system was installed using both mechanical fixing and liquid detailing, supported by in-house supervision and Sika technical inspections.

The refurbished roof now meets modern regulatory standards, improves thermal performance, and extends the asset's life. Meticulous detailing and strategic planning ensured minimal disruption and excellent waterproofing performance.
